**Southern
Cross Dental**

SCD CASE STUDY

Implant Rehabilitation

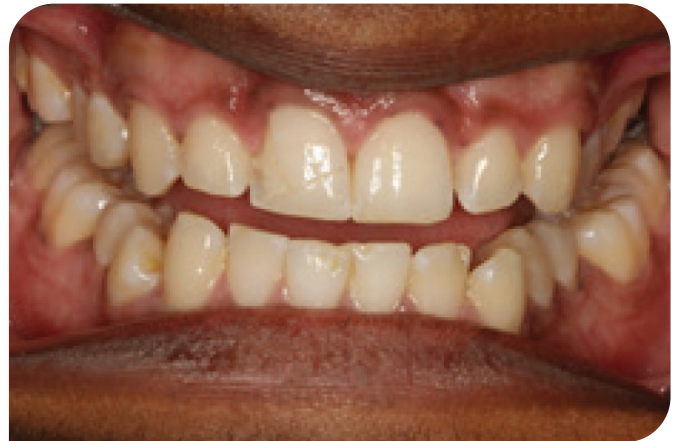
FIG. 1

The patient presented to the surgery after a football accident when he was knocked in the mouth (Fig. 1). The trauma and pain caused the patient to present to the local hospital for pain relief.

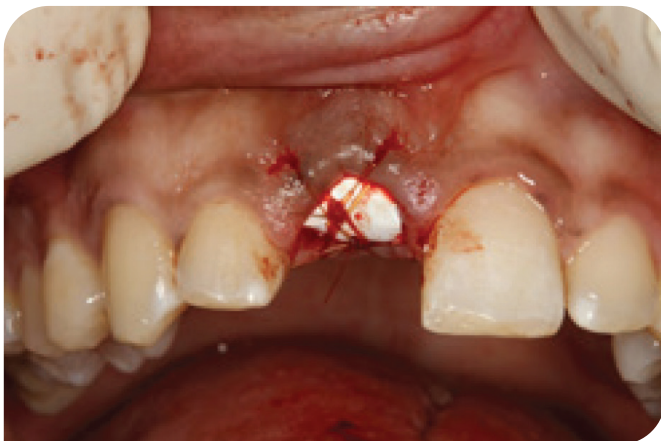
FIG. 3

The bone was prepared for placement of an implant into 11 socket. The implant placed was IA43-12d-13 4.3 mm X 13 mm TRI-NEX CO-AXIS 12 degree angled (LOT 084D04d2n02) which was torqued to 50Ncm. A 3.5 X 3.0 mm WIDE healing abutment was placed. Bio-Oss .25g graft was placed around the implant and into the socket to keep the ideal gum shape. The Bio-Oss and top of the implant were covered with Cytoplast™ GBR-200 membrane to help keep the bone graft material intact. The socket area was sutured to keep the membrane in place (Fig. 3).

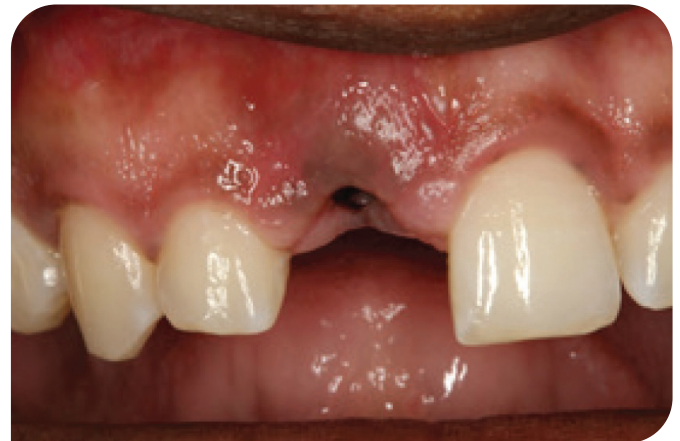
FIG. 4a

This was scheduled for 2 months after the implant had been placed (Fig. 4a and 4b).

An impression of the implant was done and no local anaesthetic was required. A shade was taken -2M1 2M2 2M3. The healing abutment was removed and a 3.5 mm impression coping was placed. The radiograph showed that all looked good. Upper and lower polyvinylsiloxane impressions were taken using AFFINIS® heavy and light body. The occlusal registration was taken using Blue Velvet for 30 seconds.

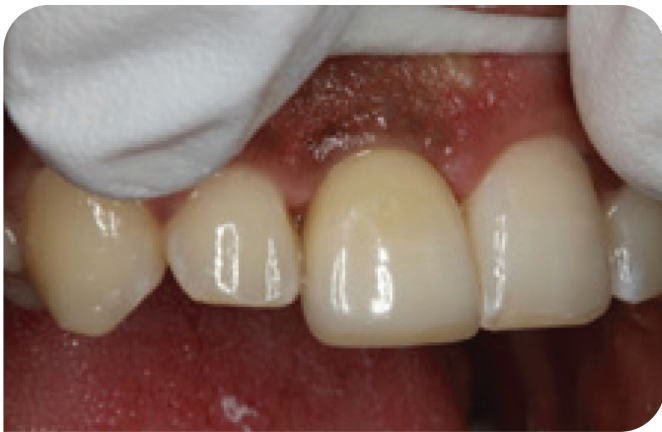
FIG. 5

Local anaesthetic was used Articaine 4% 1:100,000 Adrenalin 1 mls buccal infiltration palatal infiltration quadrant 1. The healing cap was removed and a temporary crown placed on 11 to 32Ncm (Fig. 5).

The access hole was filled using silicone tape. Metal primer Surpass® 2 and 3 (self-etching bonding system) and CLEARFIL MAJESTY™ Flow A2 G-aenial™ P-A2. The occlusion was checked, adjusted and polished. Post-operative Panadol was advised.

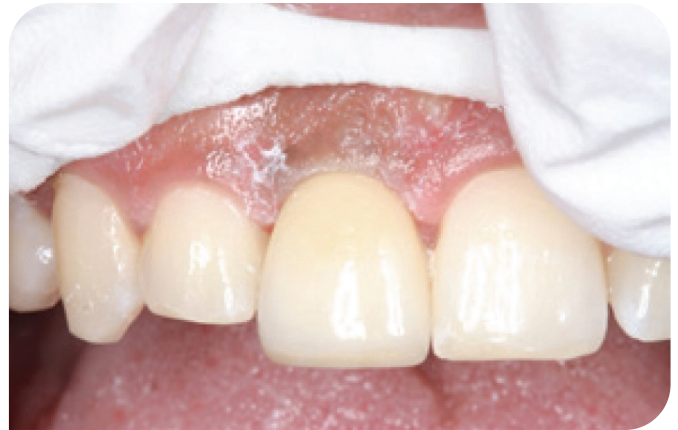
FIG. 6

The shape of the crown was evaluated at the beginning of the visit. The patient and the dentist were happy with the shape and shade of the crown. The new implant abutment crown was screwed in to 35Ncm and the crosspin tightened (Fig. 6).

At a subsequent appointment, the opposing 42 was adjusted by 0.5 mm. Tooth 42 was anaesthetised with Articaine 4% 1:100,000 Adrenalin 1.8 ml by buccal and lingual infiltration in the 42 area.

The 42 was checked and adjusted to ensure that the 42 was not hitting hard on the 11 crown.

The 42 was sealed using GLUMA® and CLEARFIL™ SE BOND. It was critical to ensure that no deleterious forces were placed over the implant. The screw was tightened on the 11 implant.
