SCD CASE STUDY

Treatment Considerations for Implant Rehabilitation

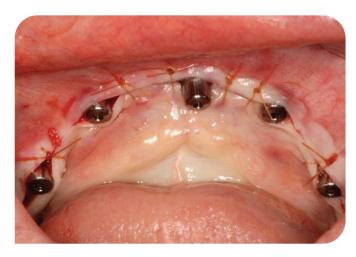
FIG. 3a Implant placement

- LA Used: Articaine 4% 1:100000 Adrenalin 10.8 mls inferior dental block Quadrant 3 Quadrant 4
- Buccal flap raised Performed osteotomy to insert implant
- 35: MIS 3.75 x 8mm Seven internal hex LOT:WO2196421 Torque 50Ncm
- 45: MIS 3.75 x 8mm Seven internal hex LOT:W13000918 Torque 50Ncm
- Coverscrew placed
- Sutured using Chromic Gut 5/0

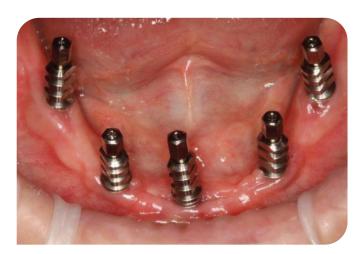
FIG. 4a Pick-up impression coping in place

- Removed healing abutments and placed MIS pick up impression copings into 45, 43, 31, 33, 35
- Lower impression using Affinis® (COLTENE) heavy and light body PVS
- · Replaced healing caps
- Took upper alginate for special tray and bite block for new Full Upper Denture
- A combination approach of both screw and cement-retained restorations both in the intermediate prosthesis and the final porcelainfused-to-metal final restorations was employed
- Fixed provisionalisation was deemed necessary to ascertain functional, aesthetic and phonetic performance

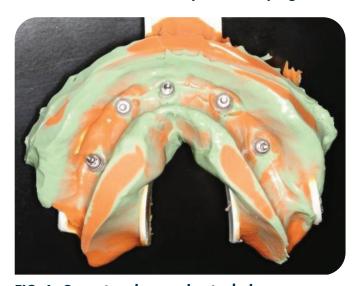
FIG. 4c Open-tray impression technique
