# SCD CASE STUDY

## Worn Dentition and Broken Down Teeth

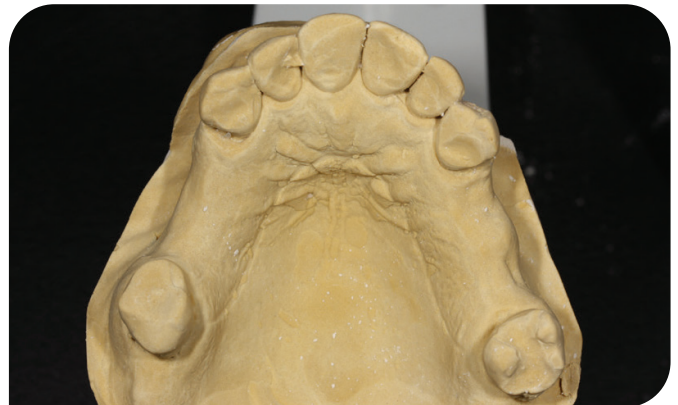
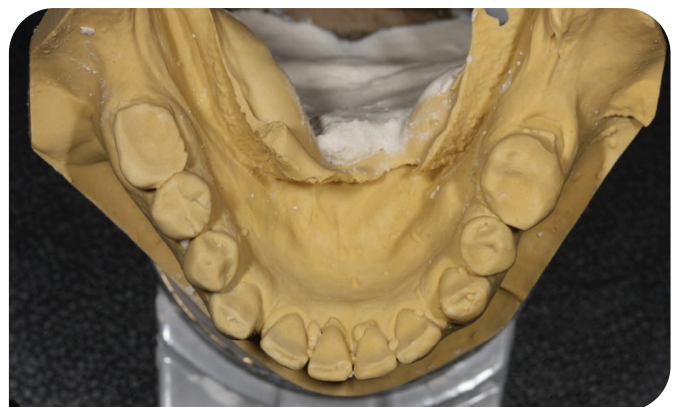
The pre-operative assessment included OPG and mounted study models.

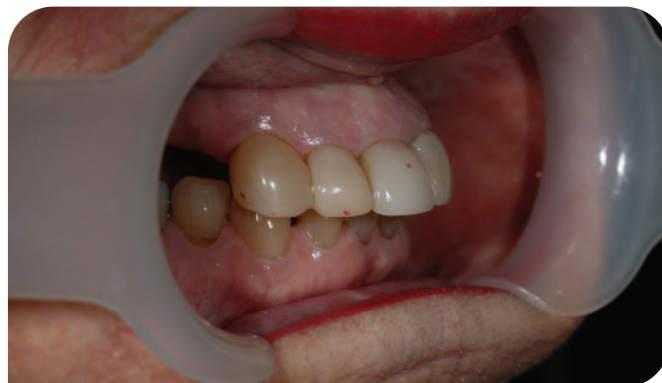
The pre-operative photographs show a combination of discoloured and worn teeth. The patient had old fillings and bonding that no longer blended with the surrounding tooth structure. The old crown on 11 no longer matched the adjacent bonding. As the natural teeth had been worn down, the incisal lengths of the natural teeth were more worn than the crown. The presence of lower diastemas was observed. Excessive overbite and loss of vertical dimension were noted. There were missing teeth from upper 14-16 and 24-26.

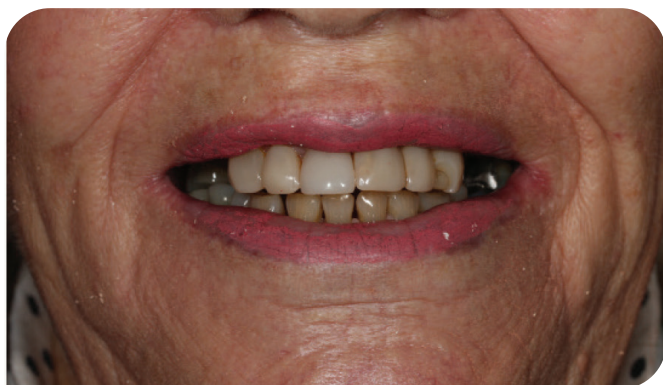
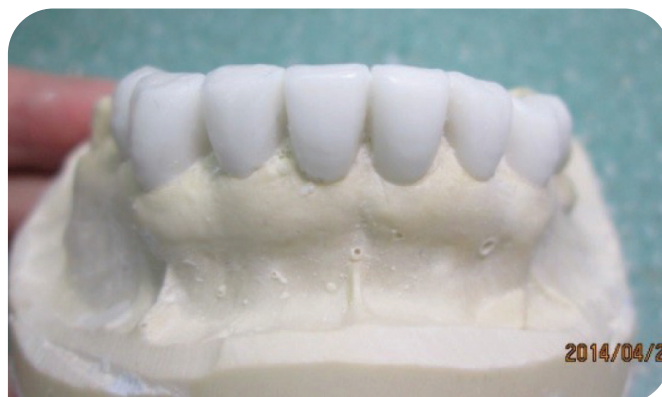
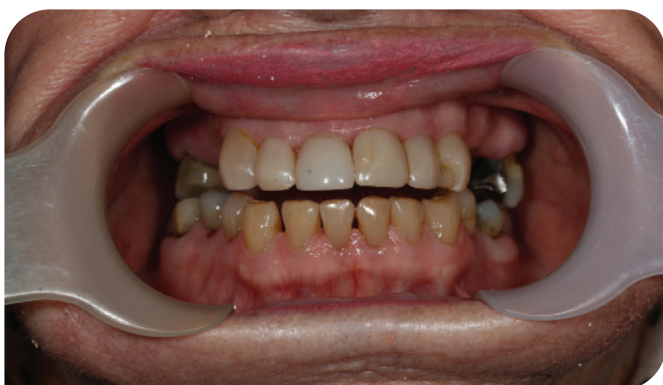
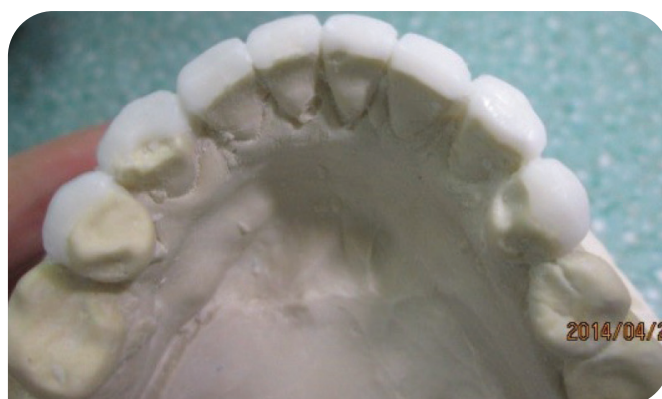
The patient was happy with her temporaries so the dentist supplied a study model for the laboratory to copy the approximate shapes and proportions for the proposed all-ceramic crowns. The lower anteriors were waxed up to restore an extra 1.0 mm in length, cover the exposed dentine on the incisors and close the diastemas.

The lower wax-up had to be harmonious with the upper crowns.

Images of the wax-up for a Penn Stent case were forwarded to the clinician for approval of shapes.

These can also be shown to the patient for further approval or if discussion is warranted. The Penn Stent provides direct composite veneers more simply by providing a custommade template after the shapes are designed in wax to give the ultimate proximal contours. Wedges and interproximal strips can be inserted into the Penn Stent to control the flow of material and reduce the amount of clean up required afterwards.

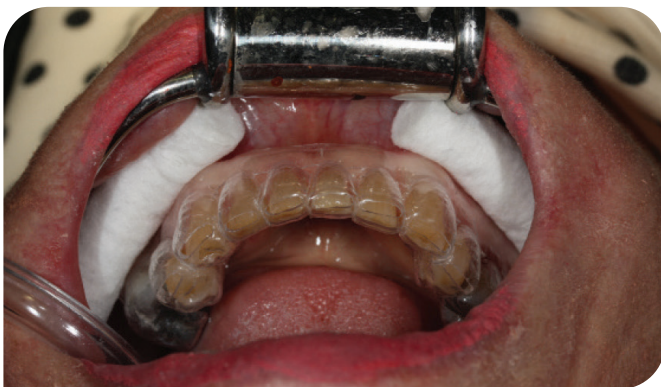
Photographs taken during composite build-up with Penn Stent.

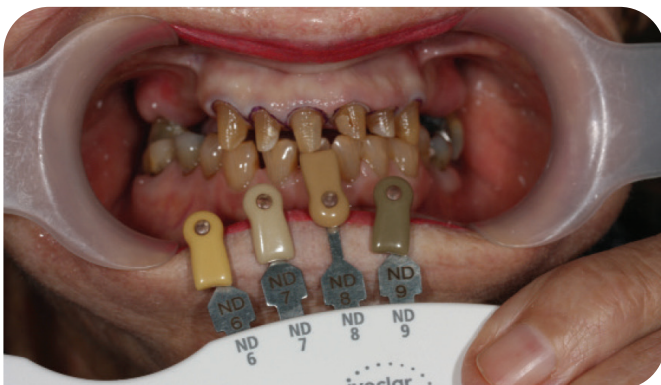
The preparation of upper anterior teeth was included in this important photograph of the stump shades which was then forwarded to the laboratory.

A lower translucency ingot was used to make the upper all-ceramic IPS e.max® crowns to block out a relatively dark stump shade. There were no posts or severely discoloured and dark root-treated teeth that required masking.

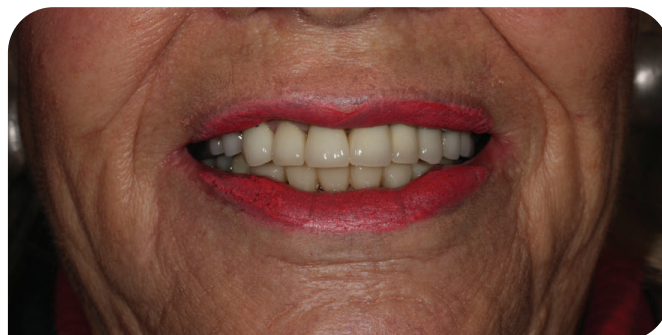
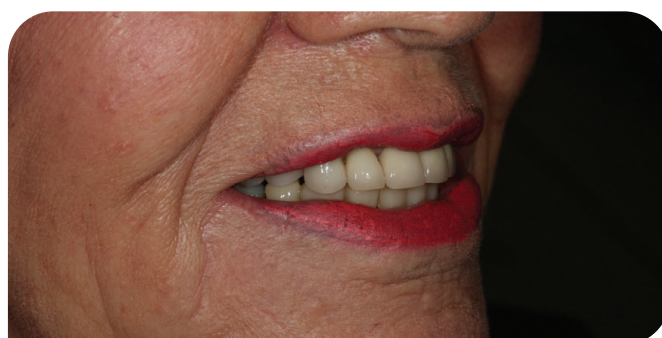
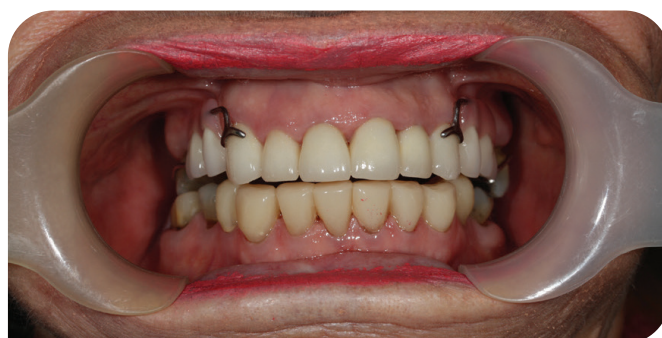
The final restorations are shown in place indicating good masking of the underlying tooth structure and pleasing contours for the patient.

The lower teeth which were built up by the Penn Stent are easy to polish and enabled adjustment of the occlusion. The slight discrepancy between the aesthetic compromise of the use of porcelain and composite in this particular case was offset by the advantage of conservative management of the lower anteriors. Both dentist and patient were satisfied with the result.
